INDIVIDUAL PROPERTY/DISTRICT  
MARYLAND HISTORICAL TRUST  
INTERNAL NR-ELIGIBILITY REVIEW FORM

Property/District Name: Woodcock Farm/Sandy Point Survey Number: WO-11

Project: Woodcock Farm Golf and Housing Development Agency: F/COE

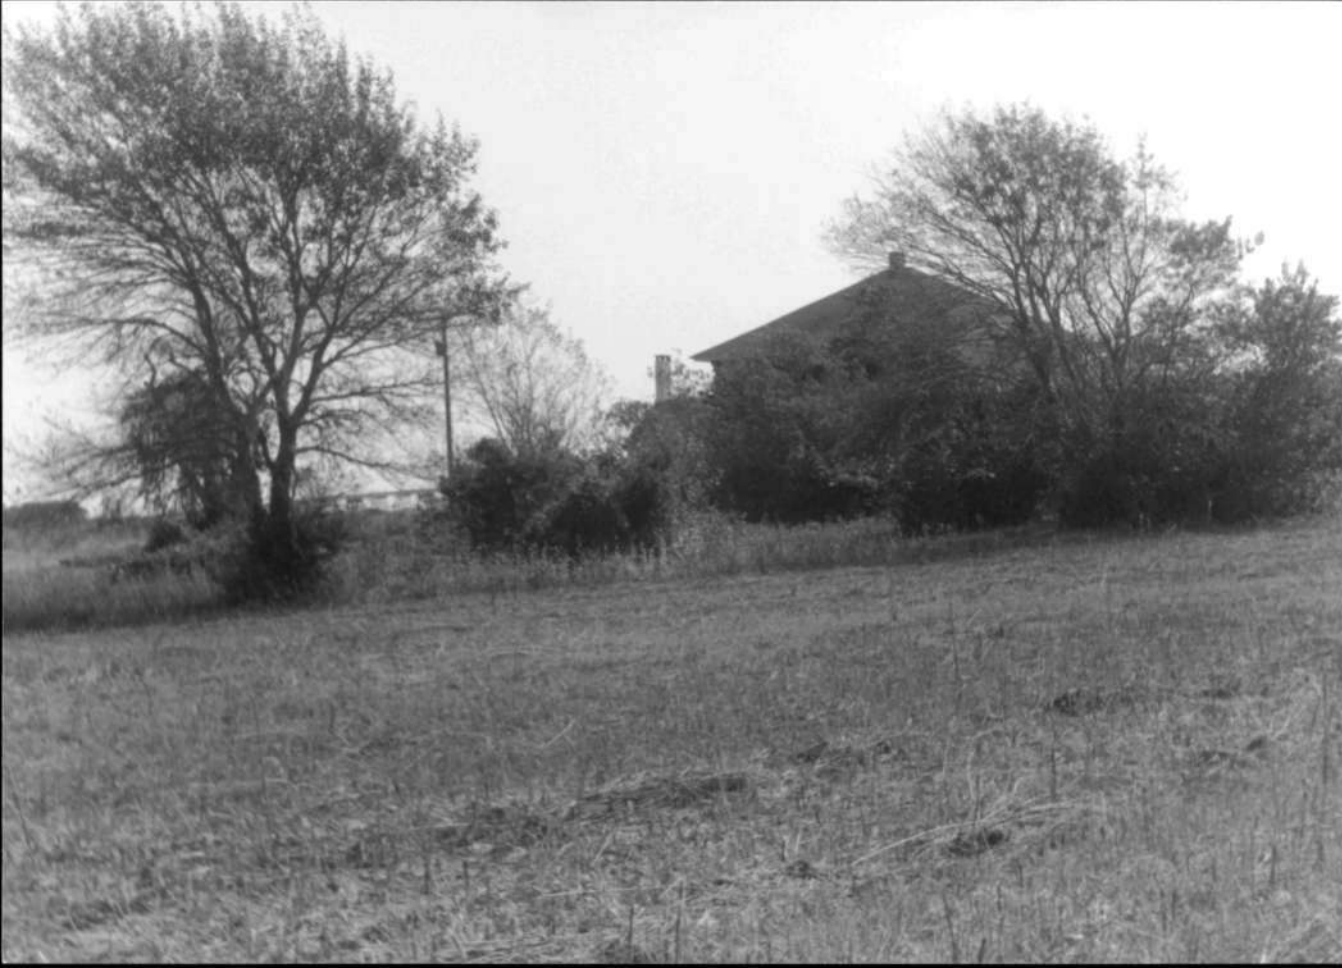
1/17

View from SW

1. View of the Woodcock farmhouse from a location and angle similar to the early photo
2. View of the south wall, from roughly the same angle as the early photo

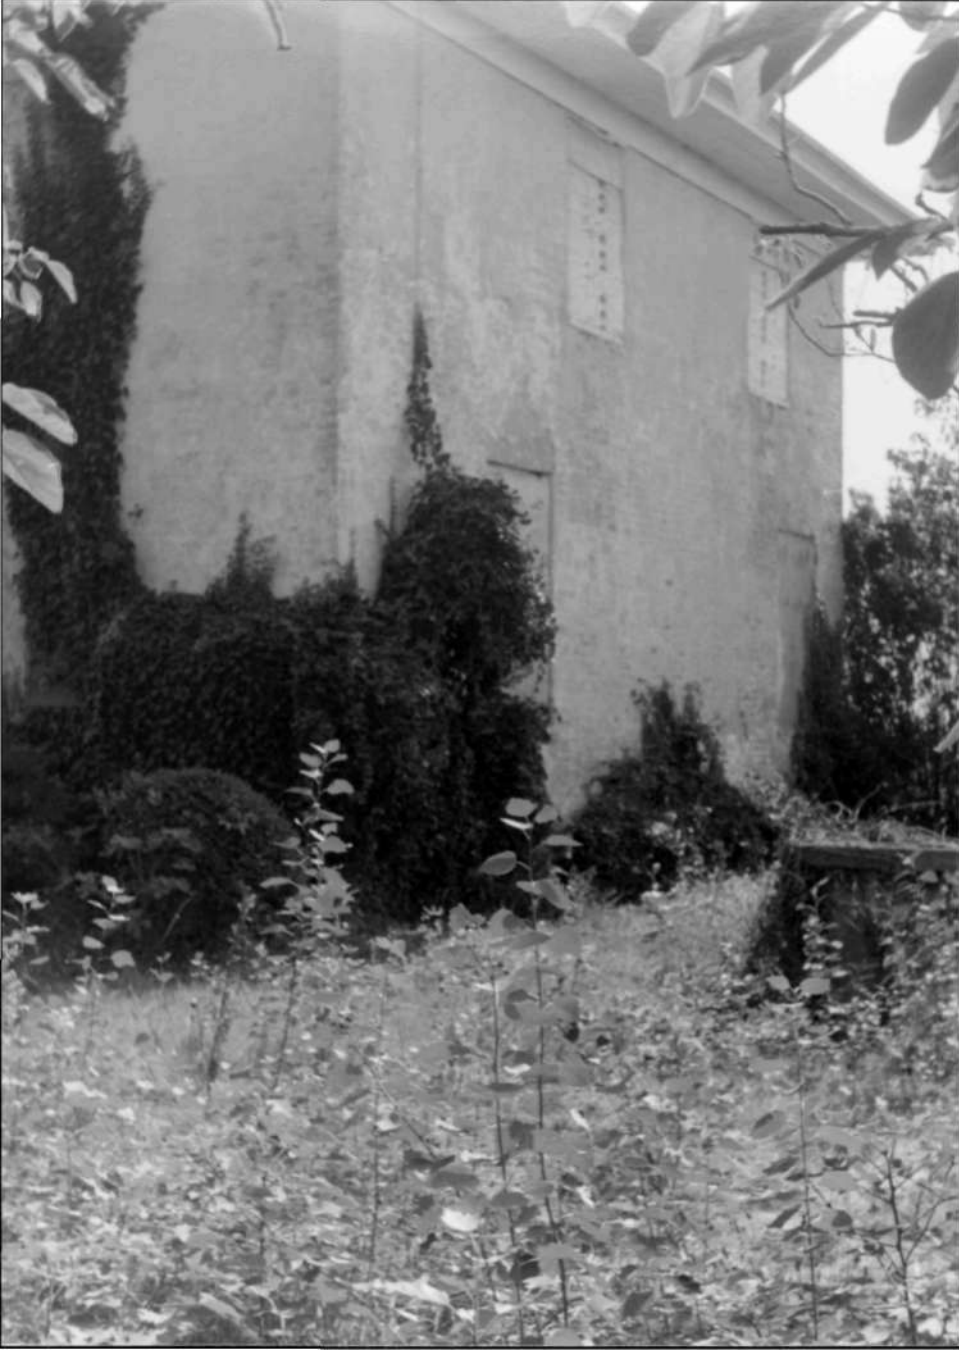
2/17

South wall  
from Southwest

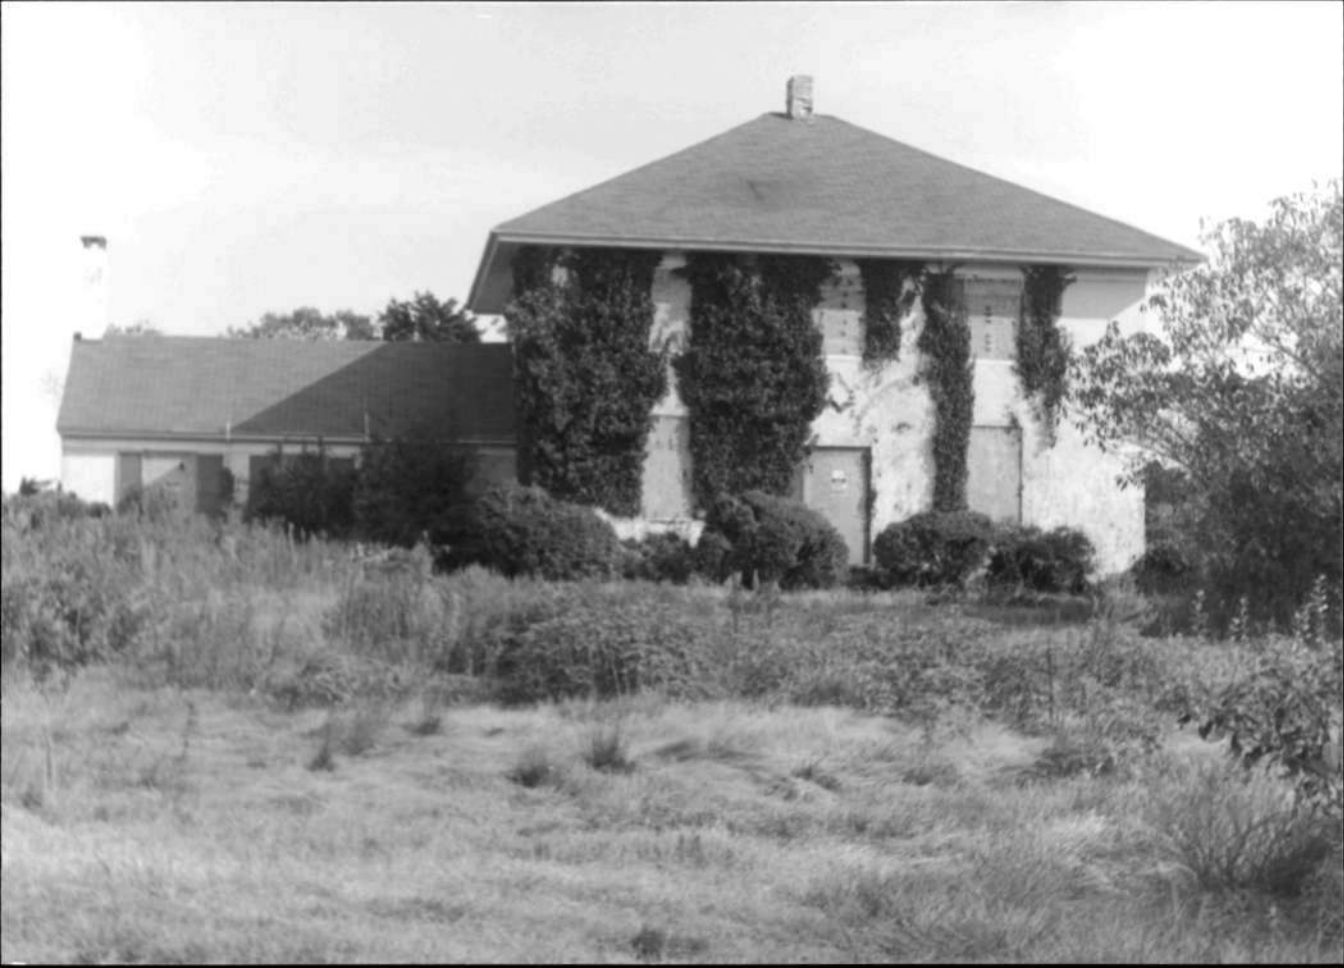
3/17

West elevation

The two-story brick house is nearly square (33'3" by 37'7"), with a one-story wing to the north. Symmetrical three-bay ashlar stuccoed facades appear on the east and west. Fenestration on the sides is irregular, however. Brickwork on the main house is Flemish bond. On the north and south walls, where stucco is missing, glazed headers can be seen, possibly in a decorative pattern.

3. West Elevation
4. North Elevation
5. East Elevation
6. View of the kitchen wing from the northeast
7. Detail of the center of the south wall, showing Flemish bond above and below water table, with glazed headers

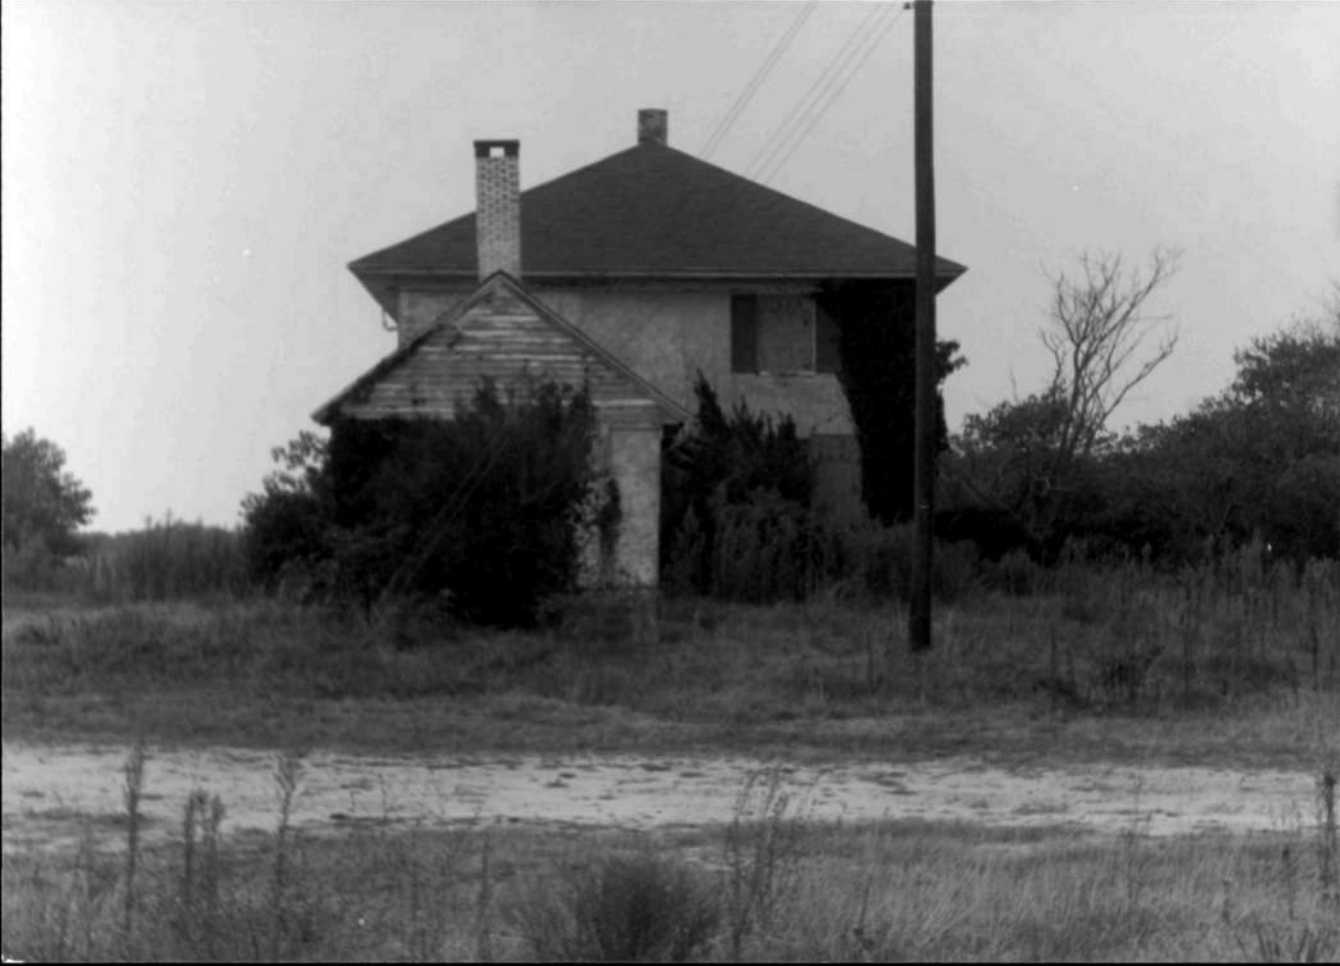
4/17

North Elevation

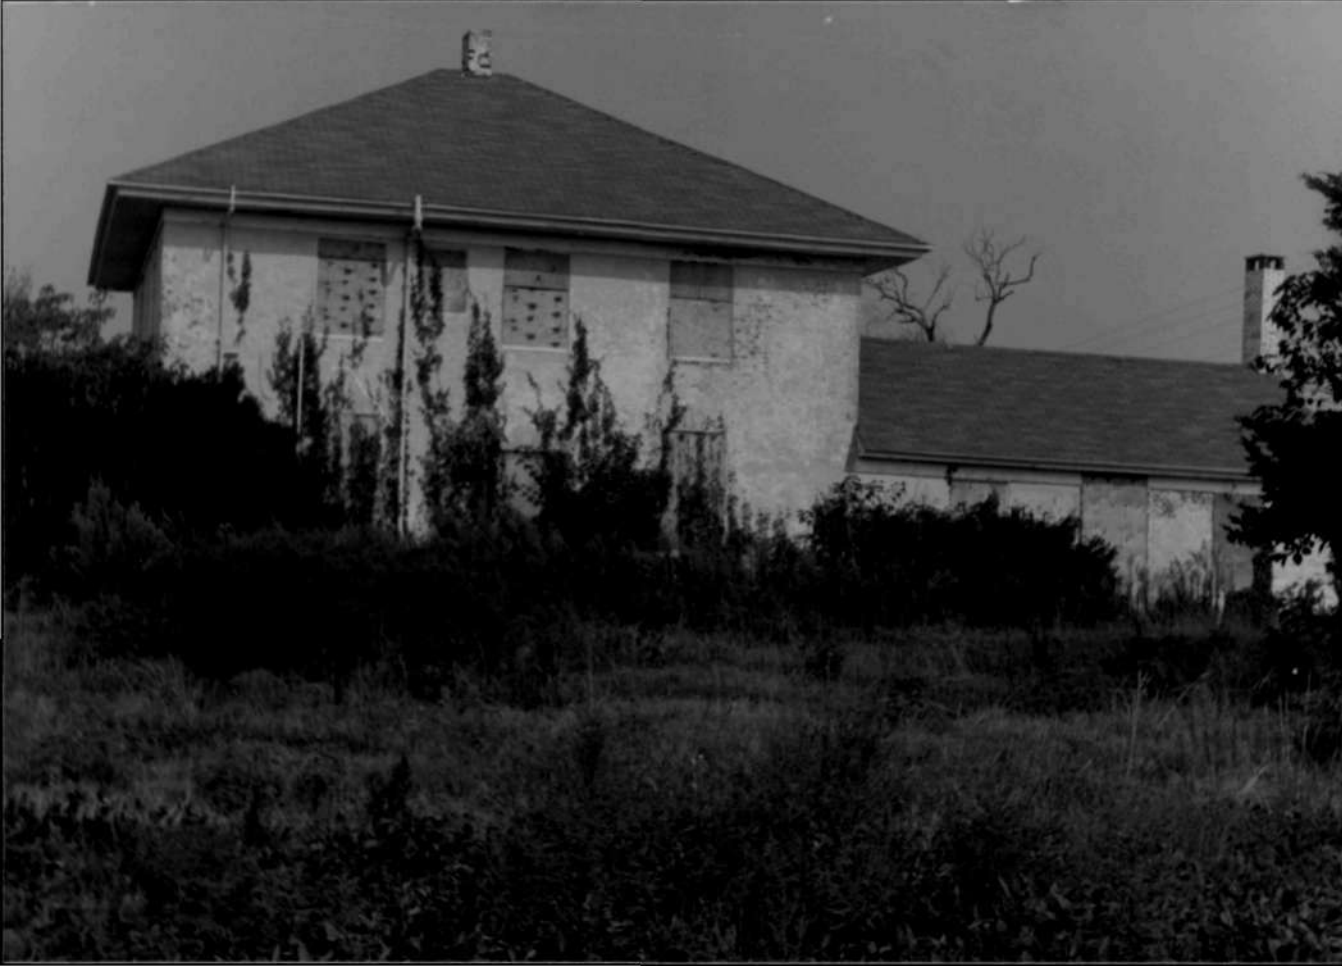
5/5

East Elevation

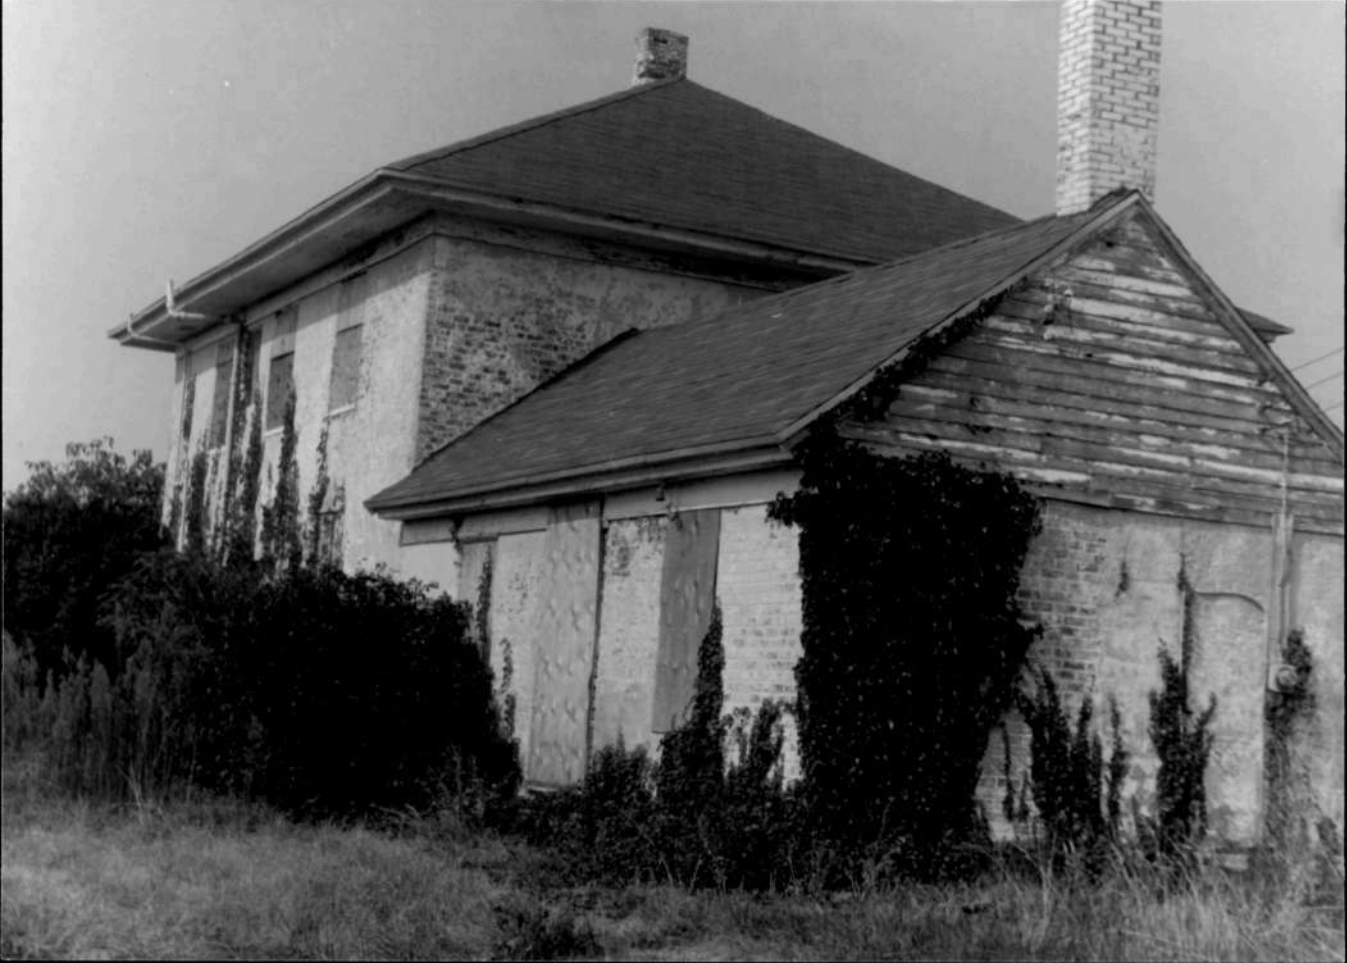
North end,  
From Northeast  
6/17

The kitchen wing apparently was added during the first half of the nineteenth century. Its west wall is stuccoed, but part of the stucco is missing from the east wall. A patch of apparently original brickwork has been exposed, to exhibit relatively smoother bricks laid in Flemish bond with narrower joints than the bricks of the main house. The northeast corner of the kitchen wing, including the chimney, is modern, with machine-made stiff-mud brick laid in common bond with simple concave mortar joints. The interior of the kitchen wing consists of a modern kitchen, a passage, and a boiler room.

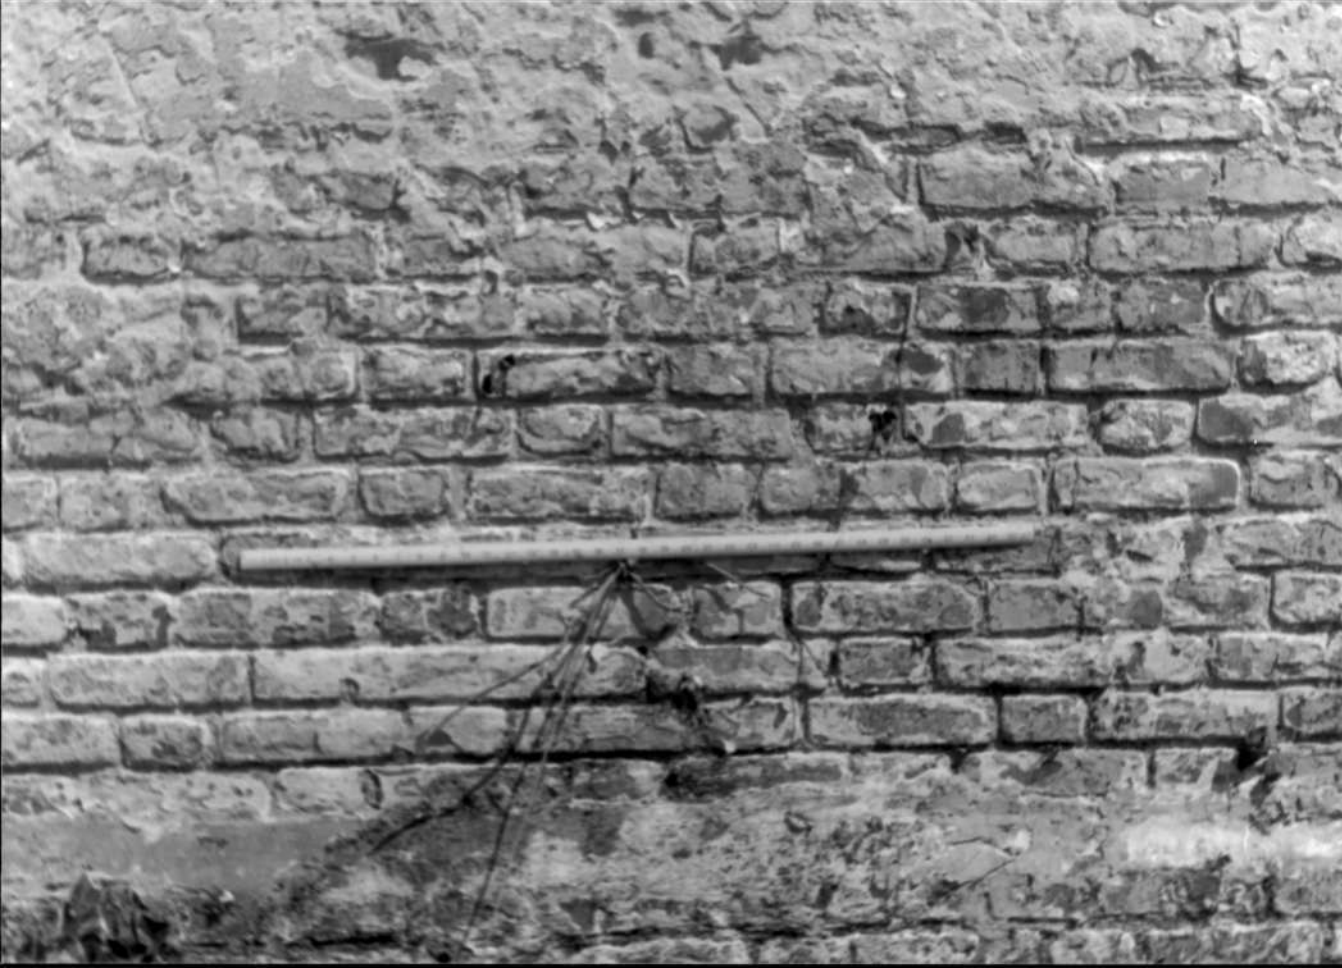
7/17

Detail, south wall

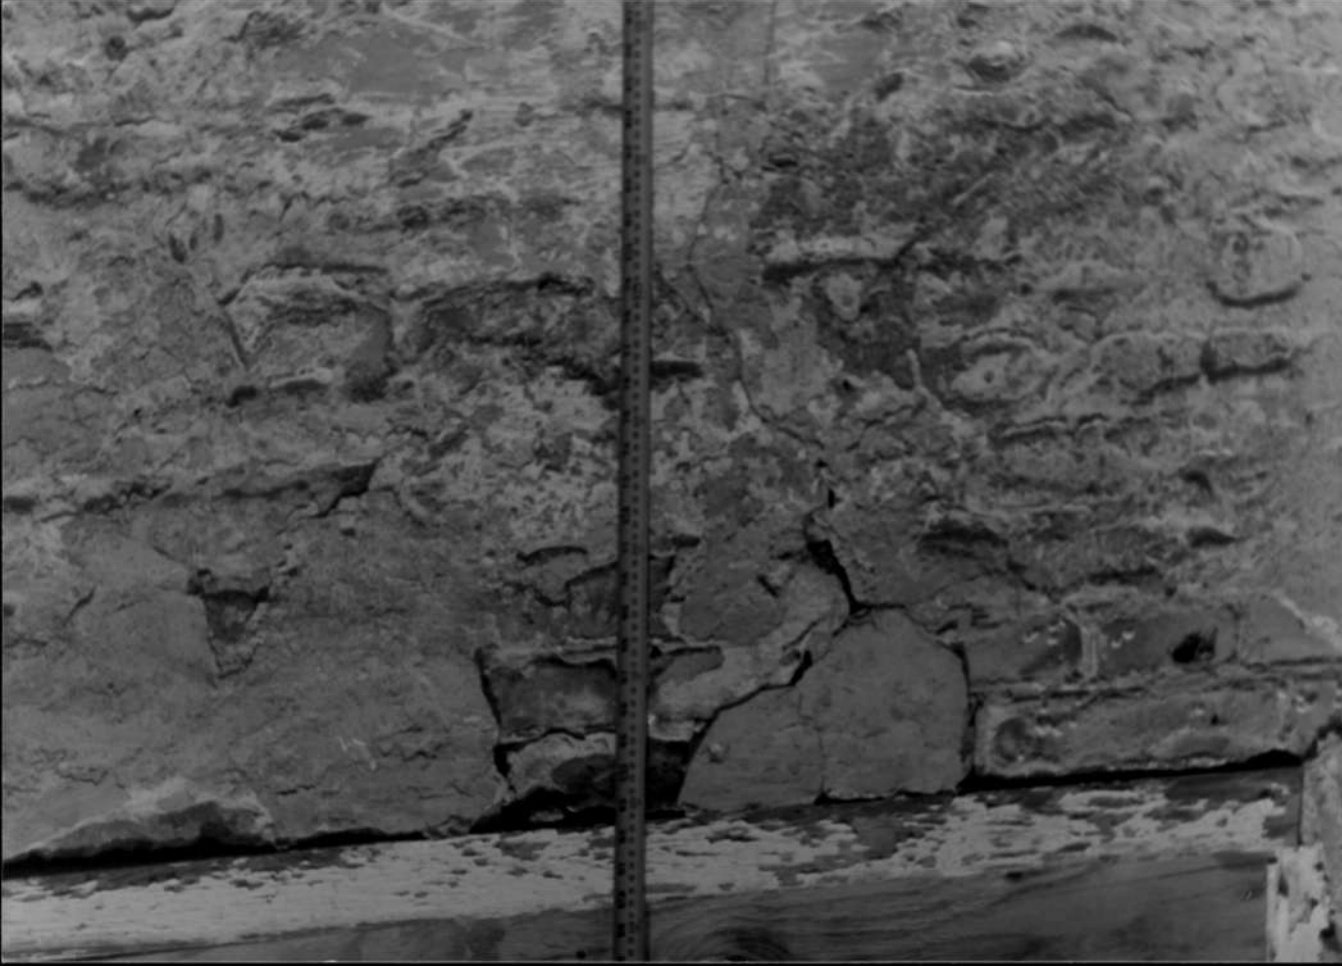
8/17

Detail, S. wall

8. Right window, second floor, south wall, showing patches in stucco
9. View of the dairy, as seen from the house
10. Southeast corner of the dairy
11. View of the dairy from the east, with the house in the background

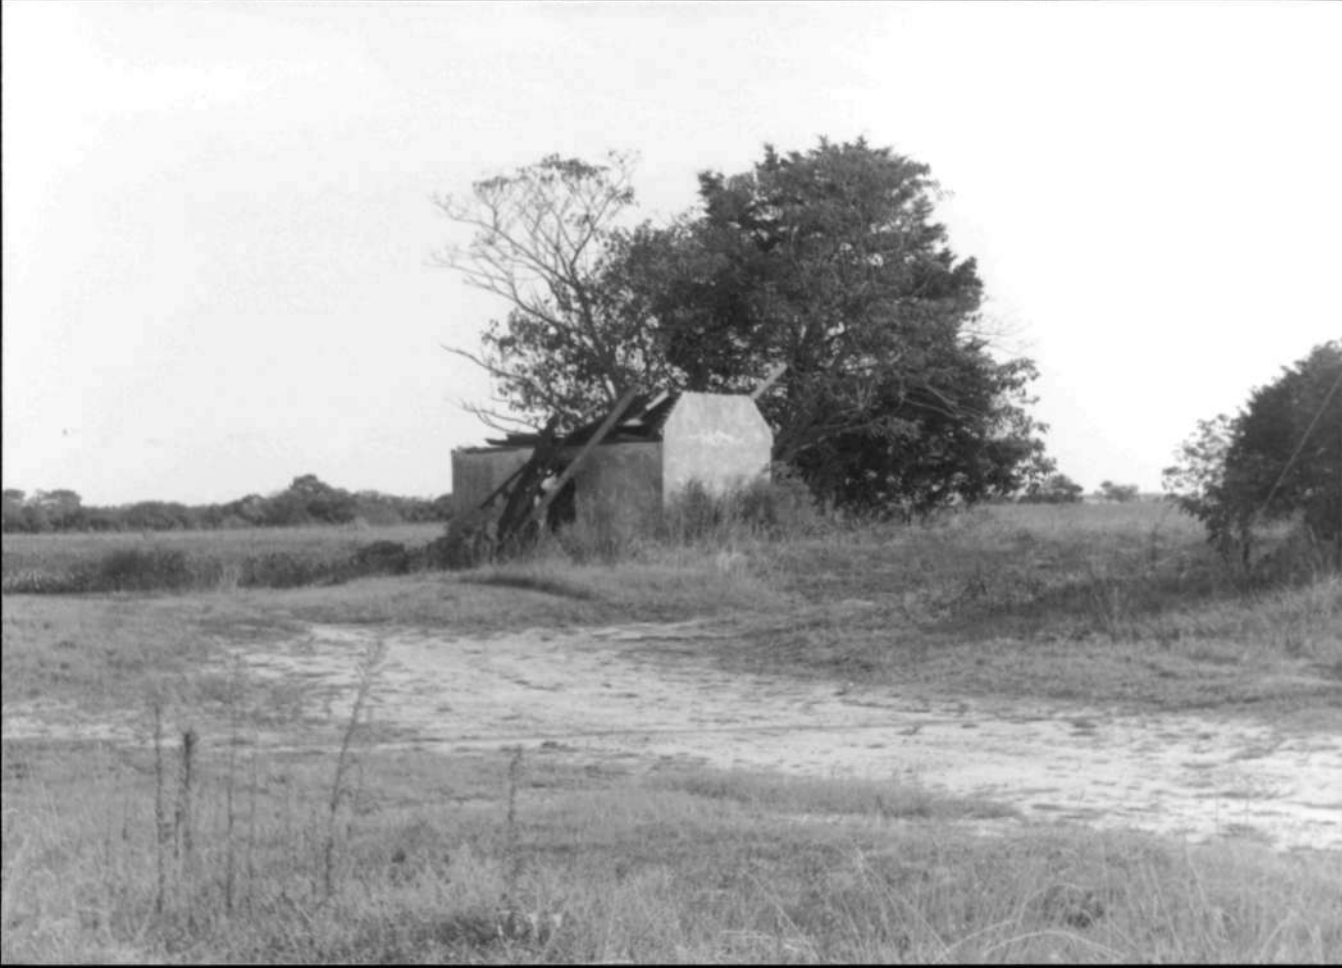
9/17

Dairy from west

The eighteenth-century dairy is a stuccoed brick building, not aligned to the main house, standing to the east, on the edge of the domestic yard, roughly 15' by 12'. Its gable roof has fallen, and its door and window trim is missing.

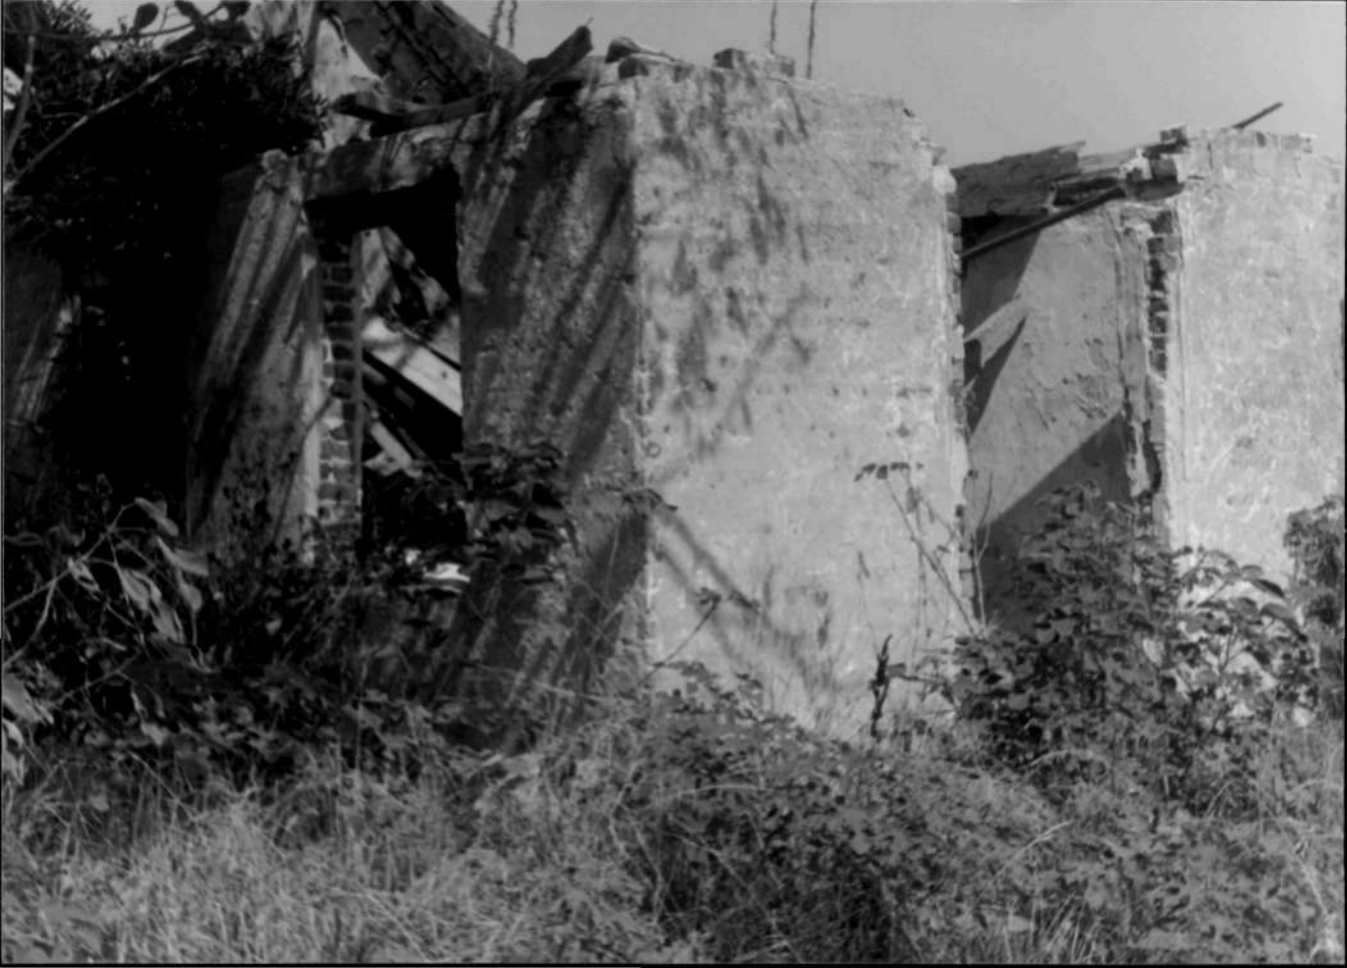
10/17

Southeast  
Corner of Dairy

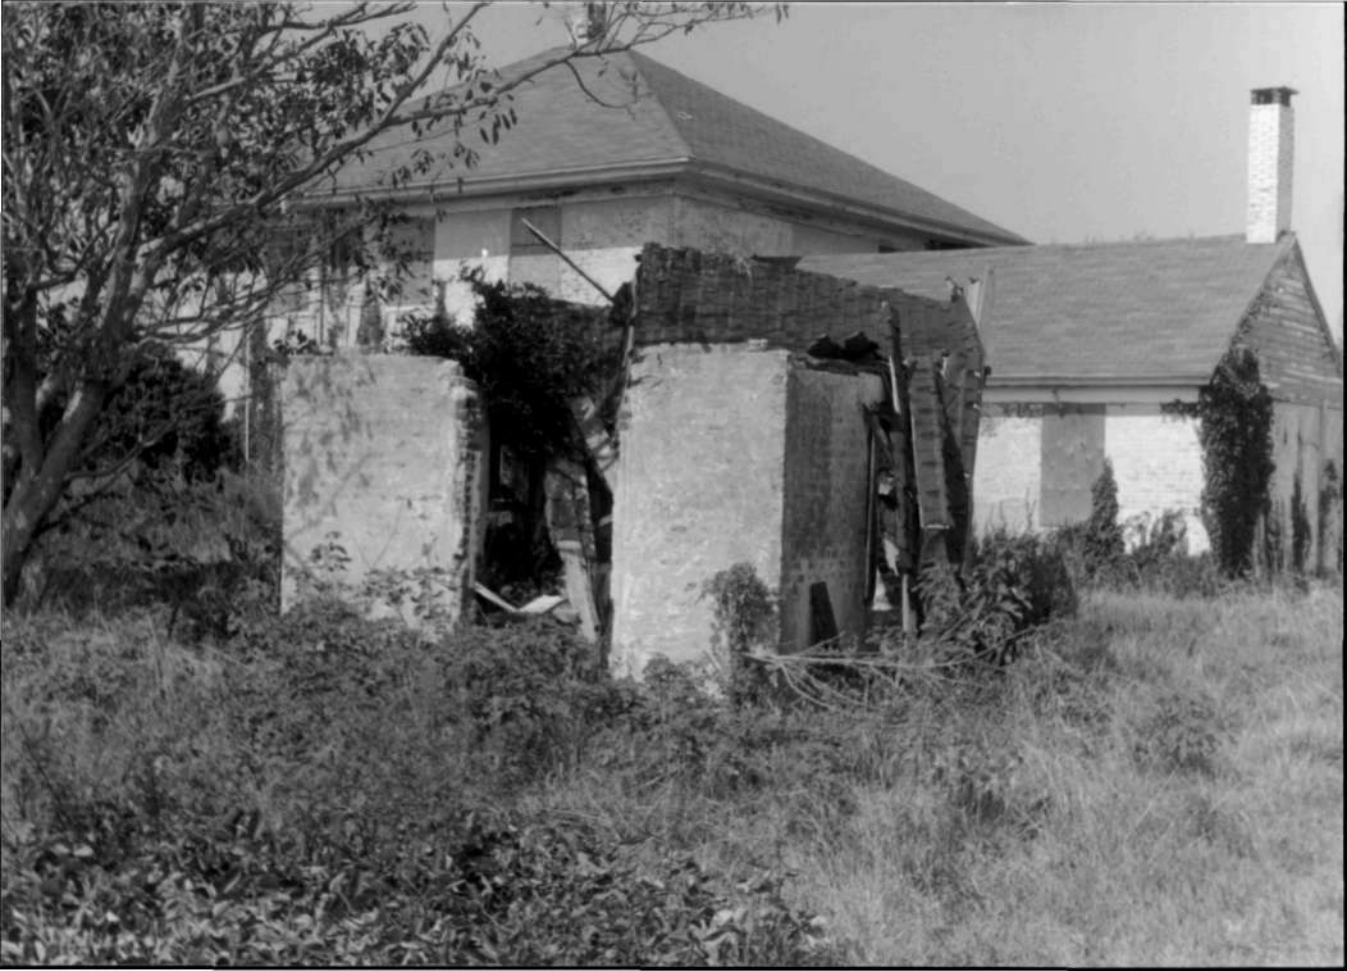
11/17

Dairy from East

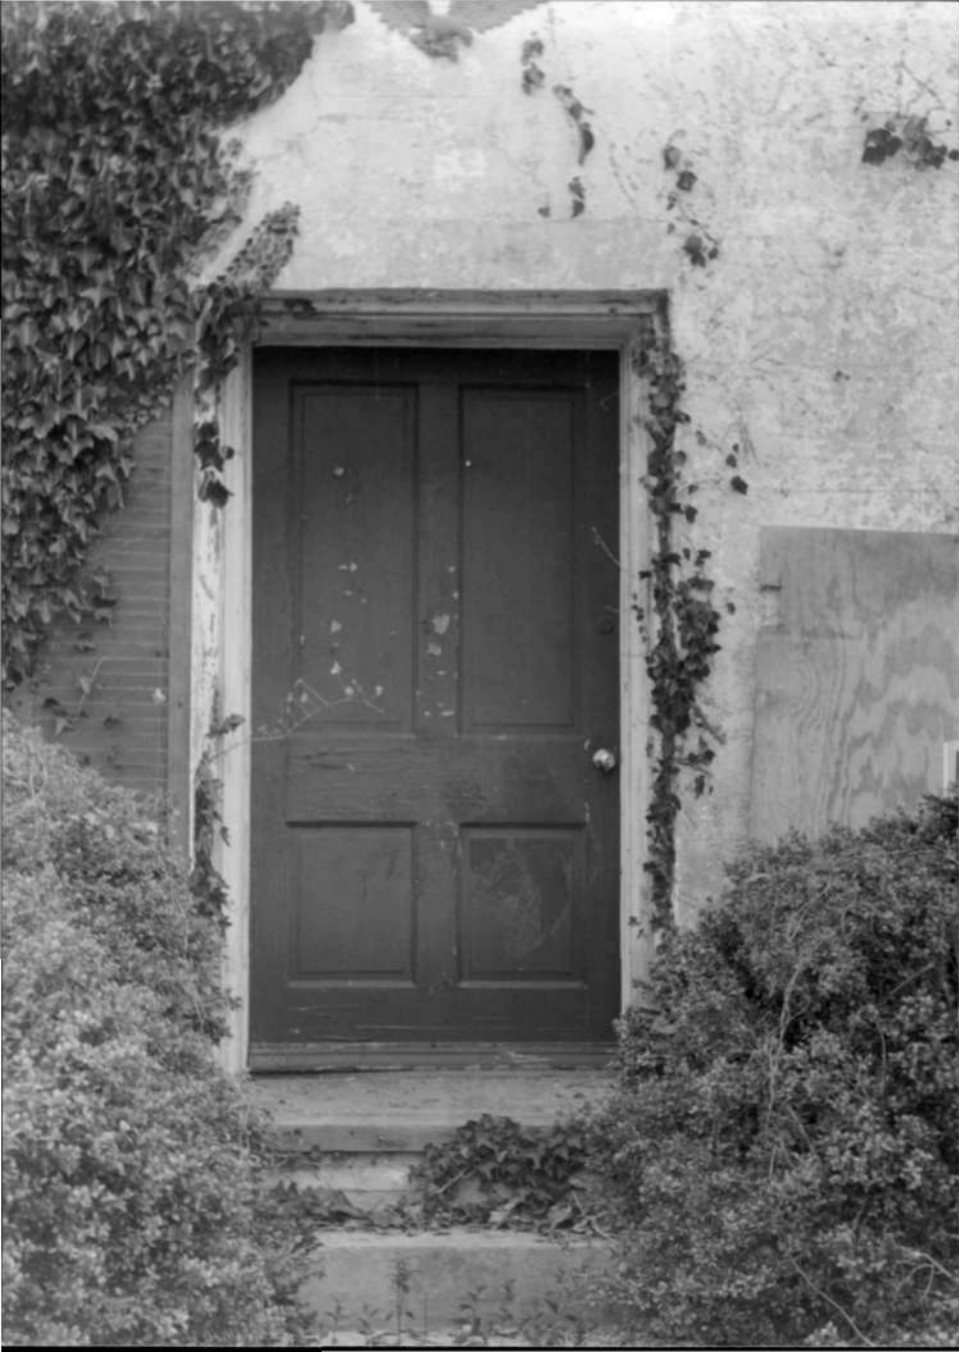
13/

West door

12. View from the dairy, down the lane toward the bay
13. West Doorway
14. Newel post near the east doorway
15. Plasterboard central wall with original brick partition wall exposed

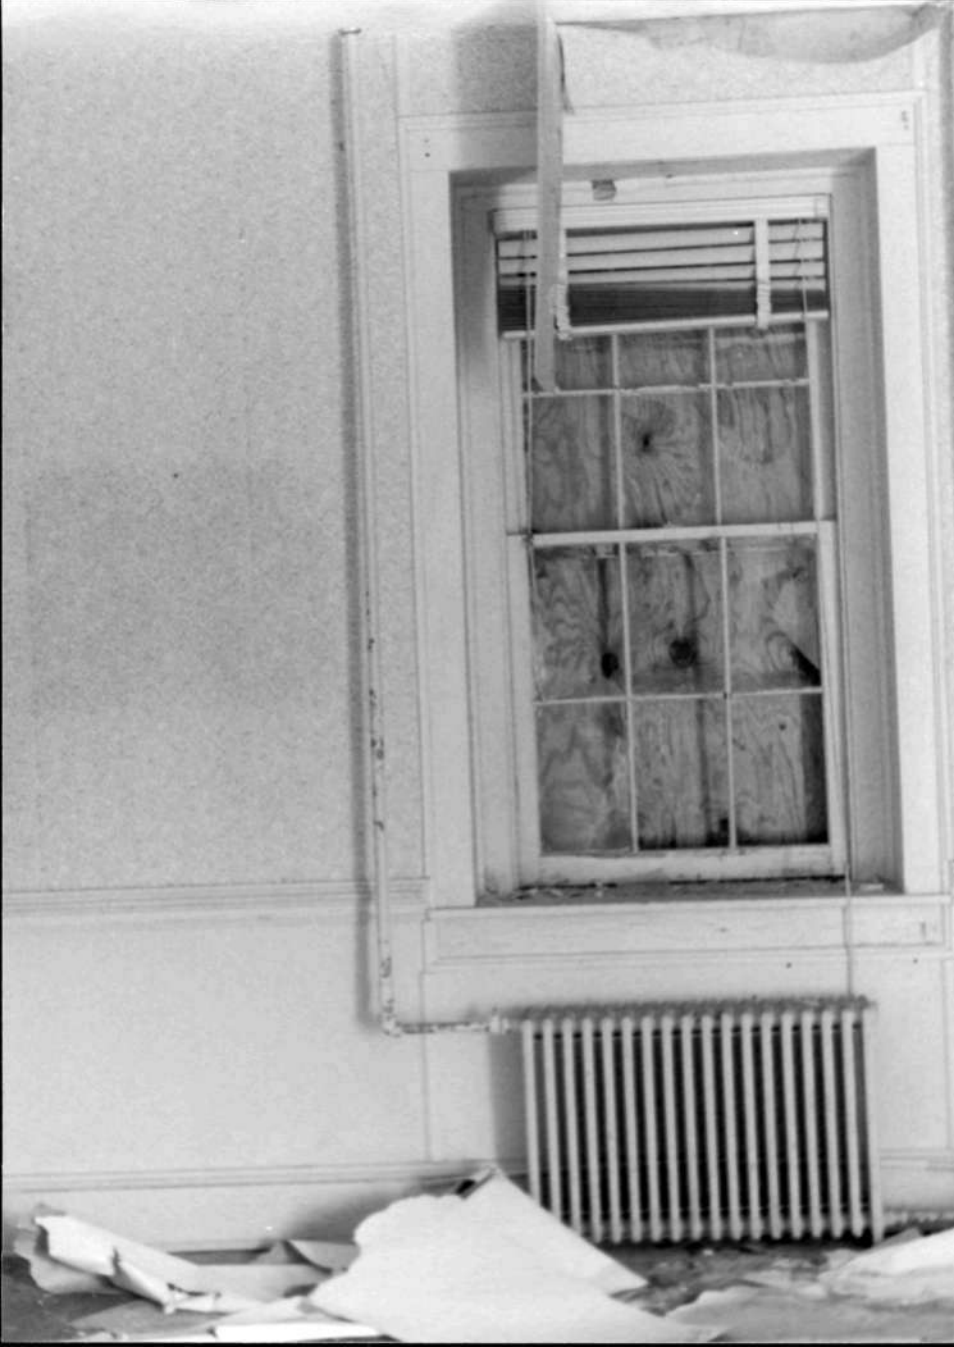
17 ' 7

West window  
South 1<sup>st</sup> Floor

17. Window on south wall of southwest room
